生物多様性を壊す巨大ダム建設(愛知県東部) 日本政府・愛知県は政策転換を！

設楽ダムの建設中止を求める会

設楽ダム建設事業 Shitara dam Project

Shitara Dam Project

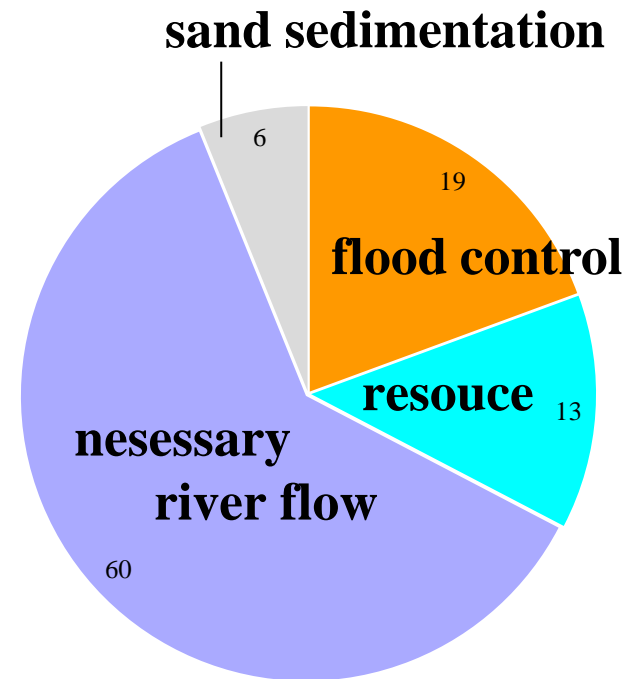
Total volume of reservoir	98 × 10⁶m³
functional volume	92
flood control	19
necessary river flow	60
municipal	6
irrigation	7

■ 洪水調節 ■ 新規水源 ■ 流水正常機能維持 ■ 堆砂

Volume % of Usage

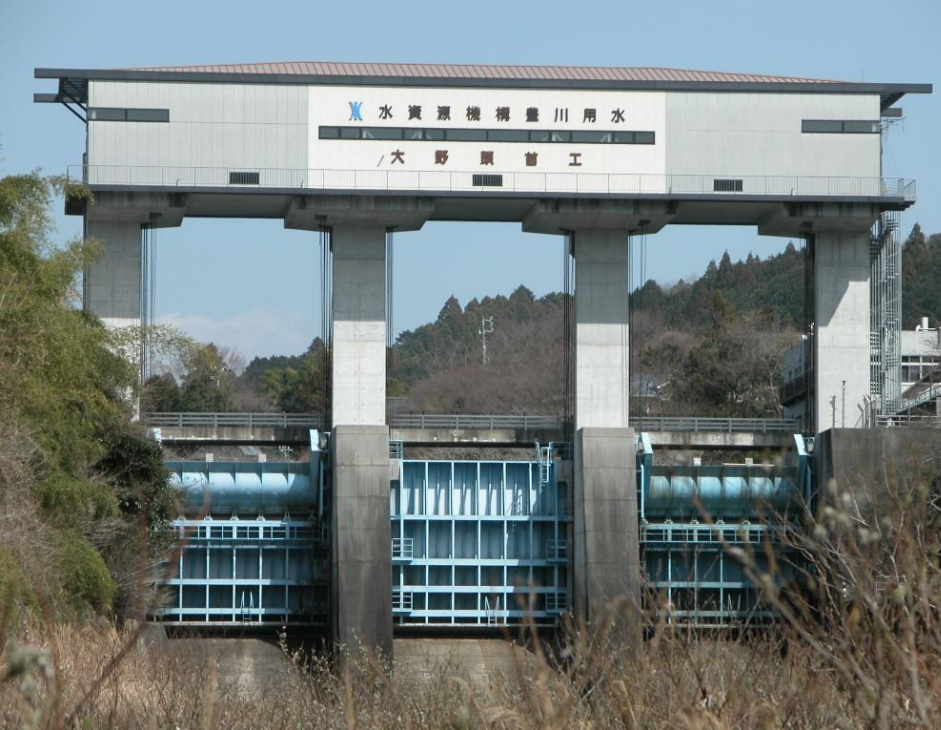
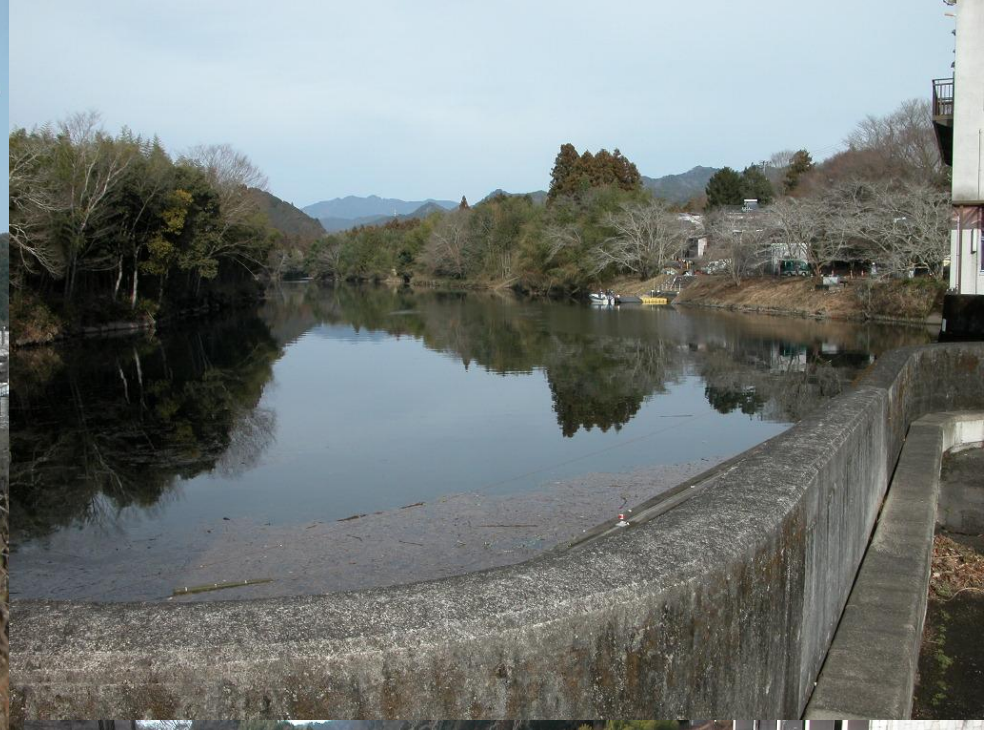
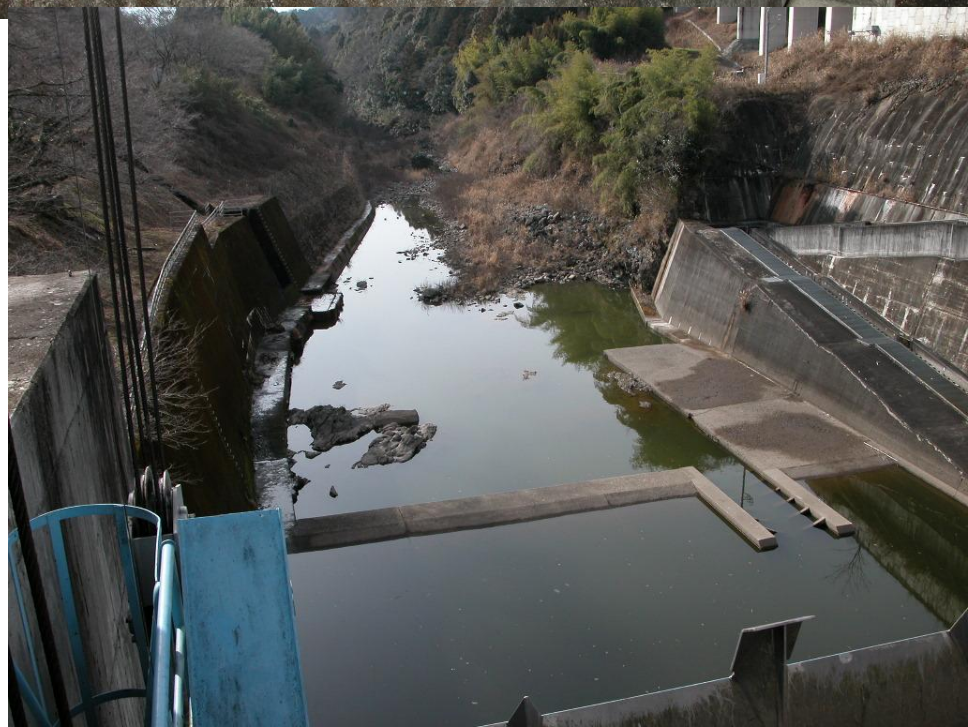
Left : Ono weir of Toyogawa-Yosui
(Ono dam, 26 m height)

right upper : Ono reservoir

right under : flow-less stream
downward the weir

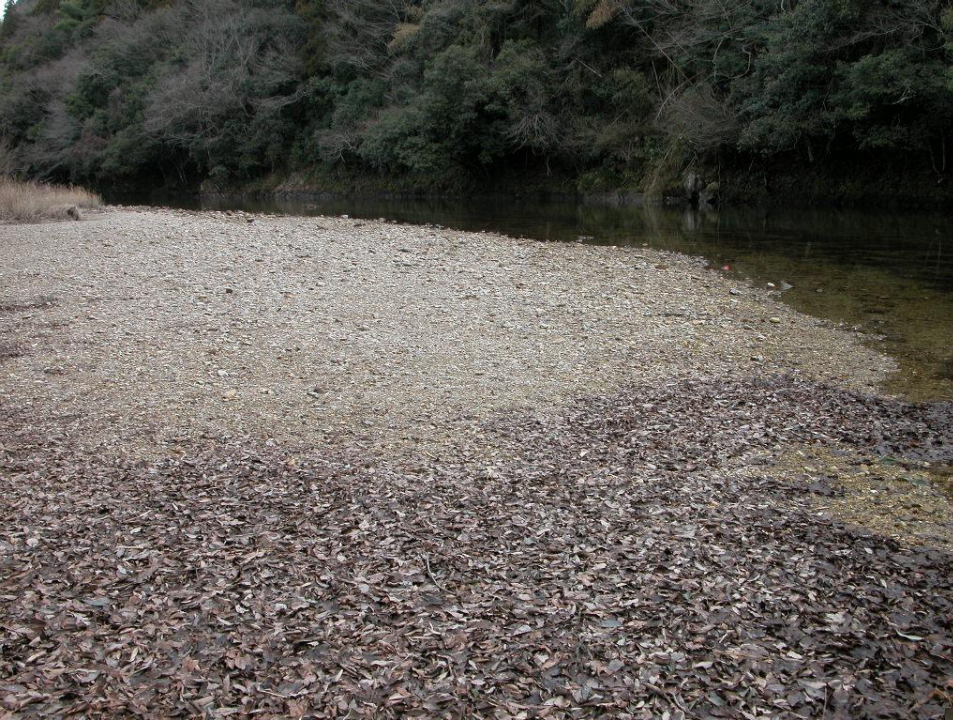
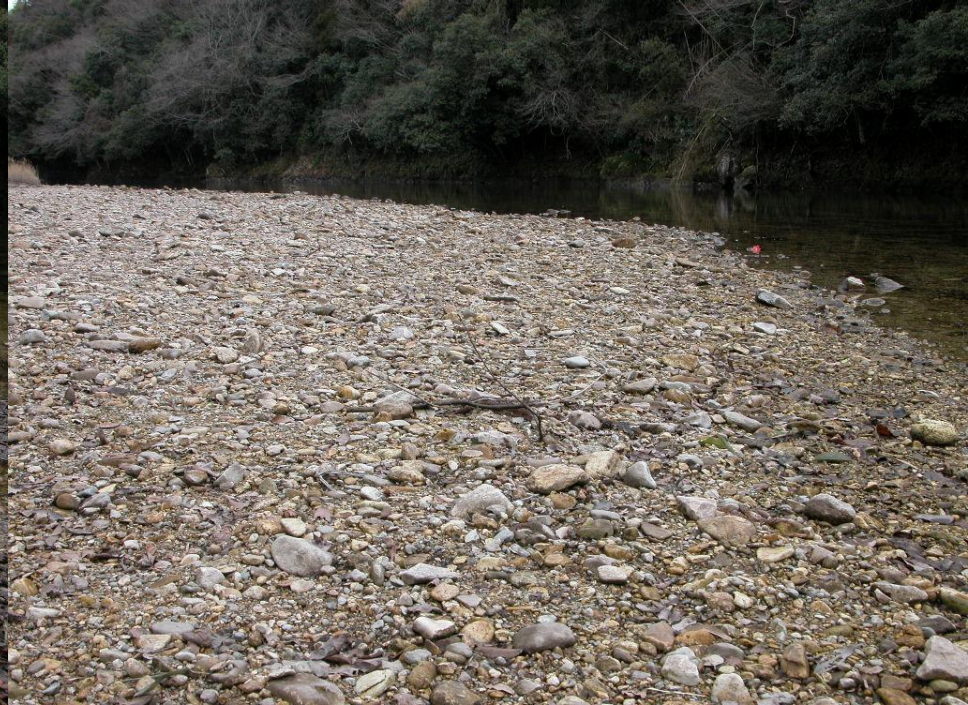
**lots of gravel sediments
containing litter at the
upstream of Ono reservoir**

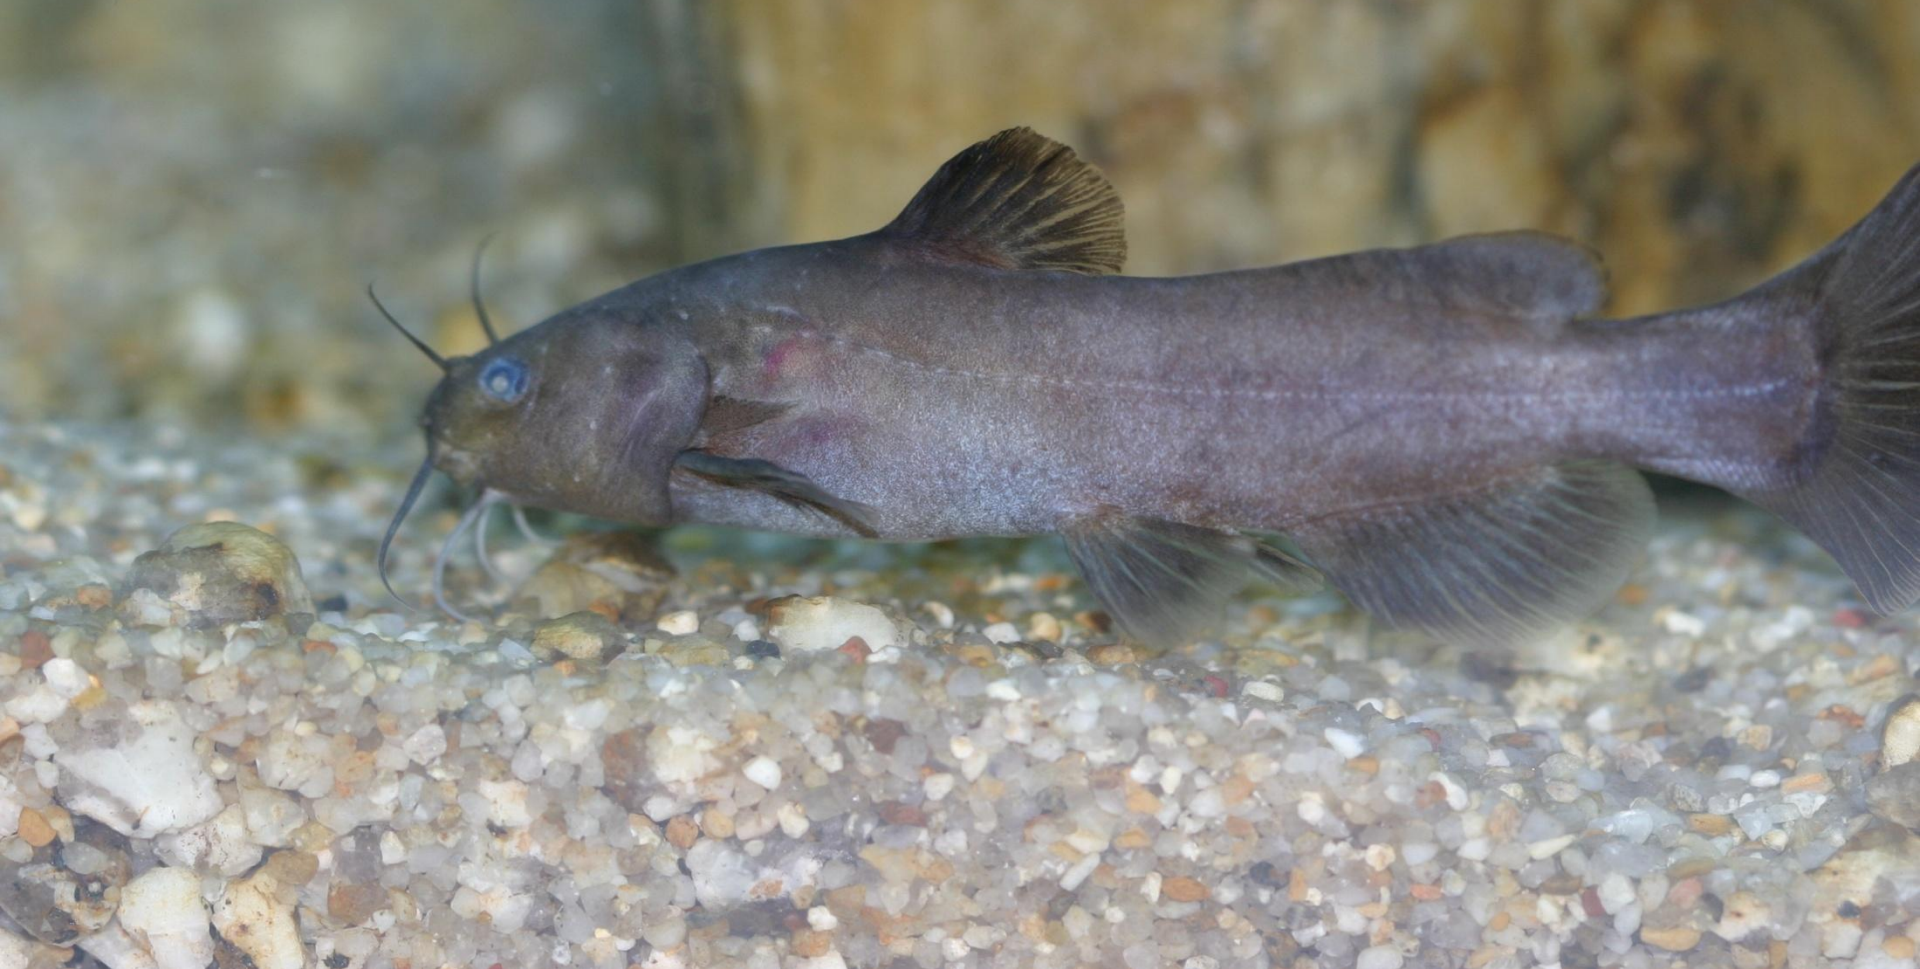
ネコギギ(伊勢・三河湾集水域の固有種、国指定の天然記念物、絶滅危惧種IB)、撮影:伊奈紘

Nekogigi (*Pseudobagrus ichikawai*)

natural monument, endangered species

It's habitat is limited in the catchment of Ise Mikawa Bay

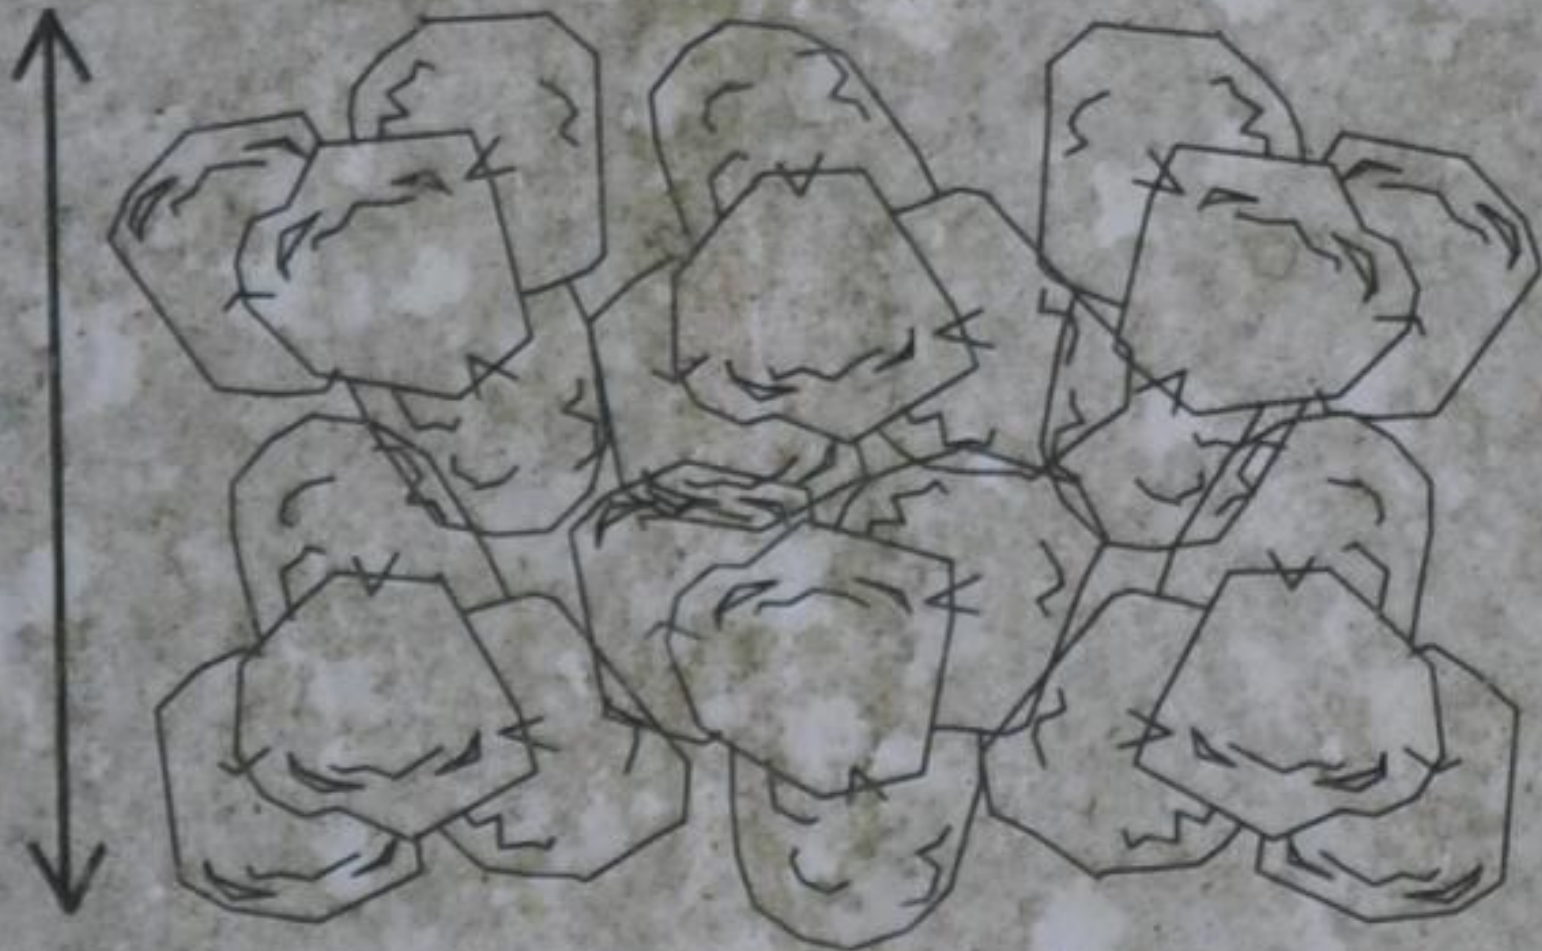
2.5m

3.5m

**an artificially constructed
habitat model for Nekogigi**

The developer tries to transplant the Nekogigi population being submerged in the reservoir to the down stream.

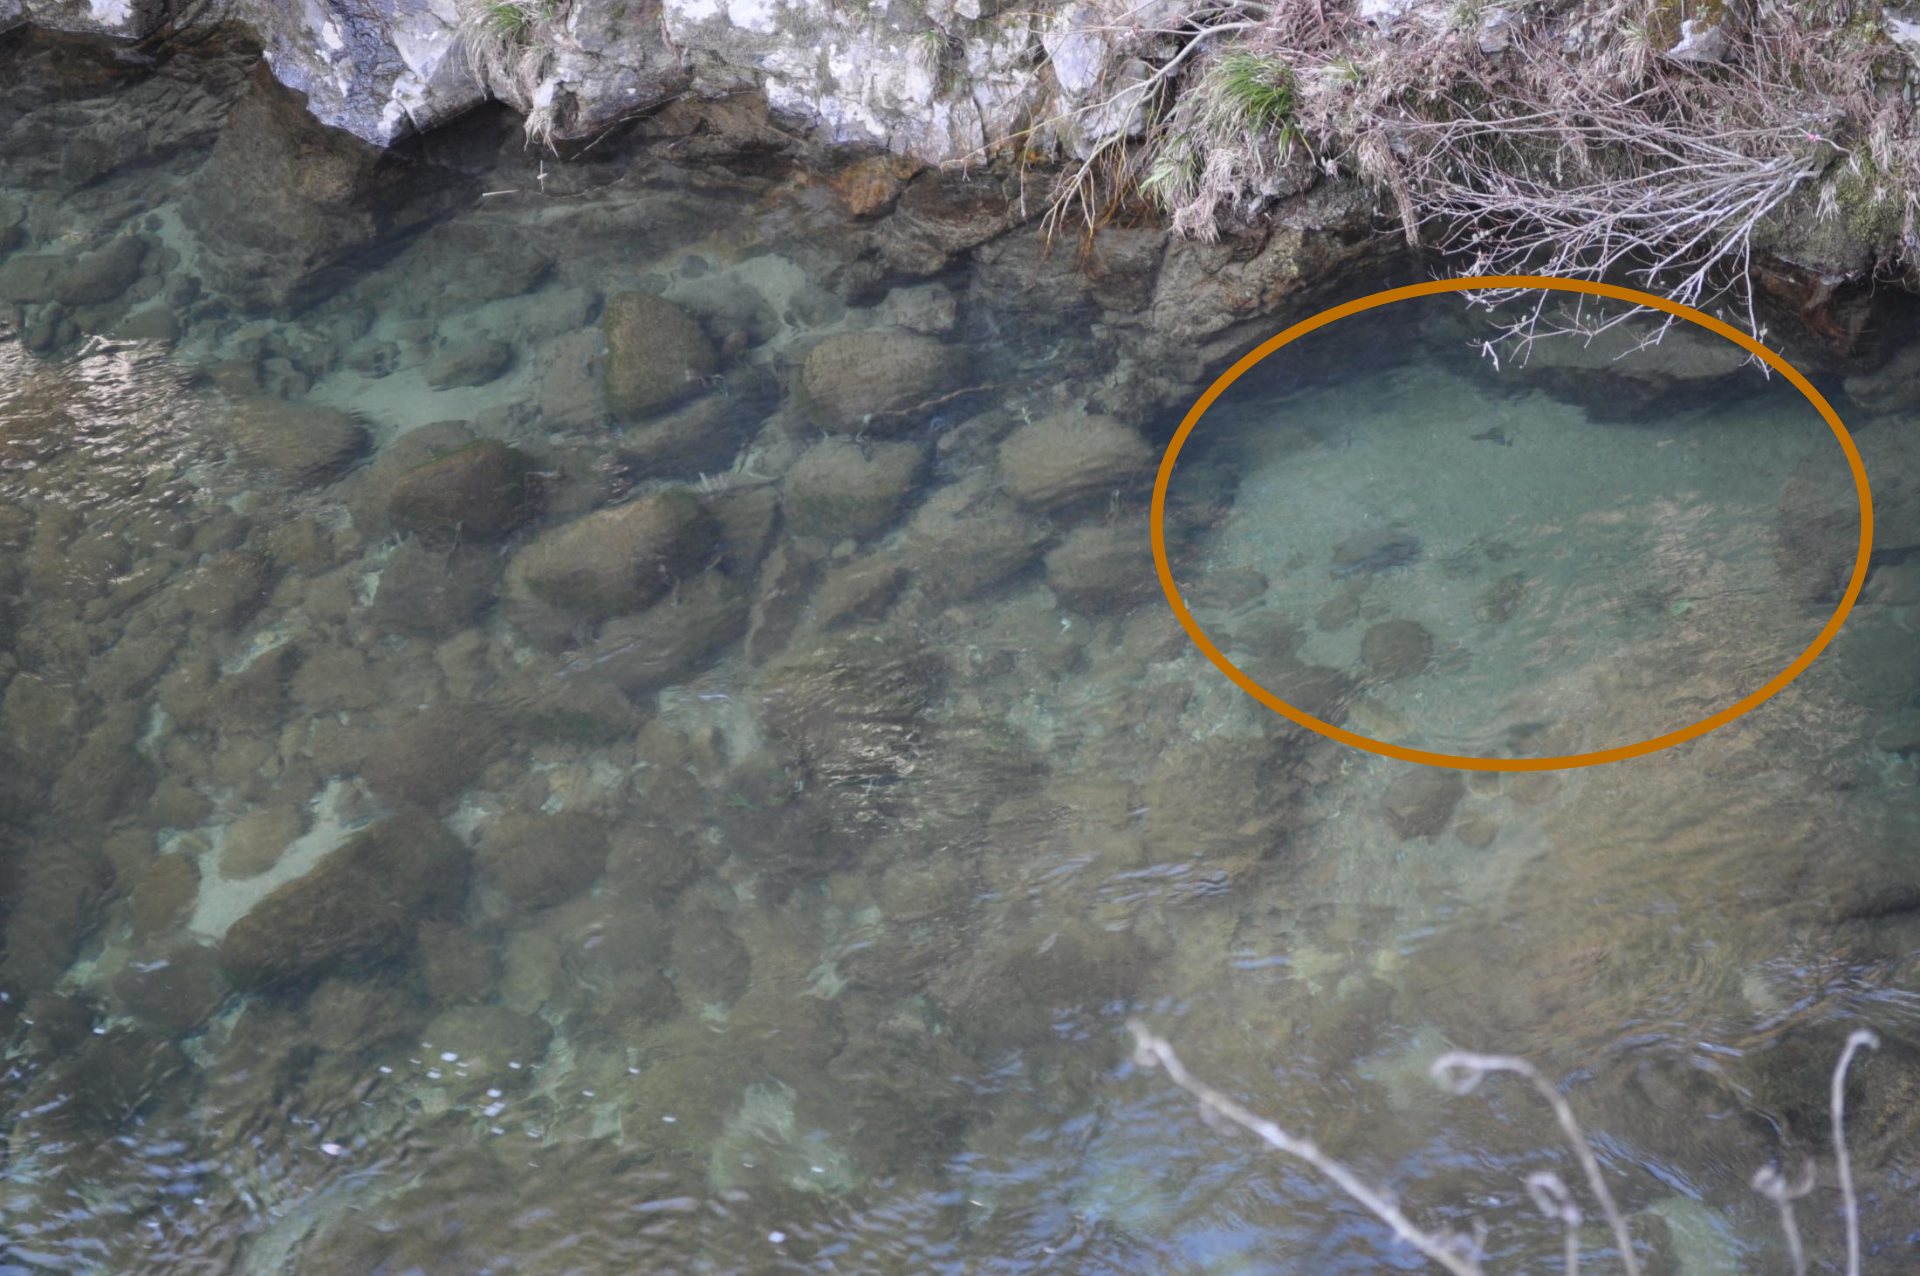
A flood of typhoon in 2011 broke the habitat model constructed rocks.

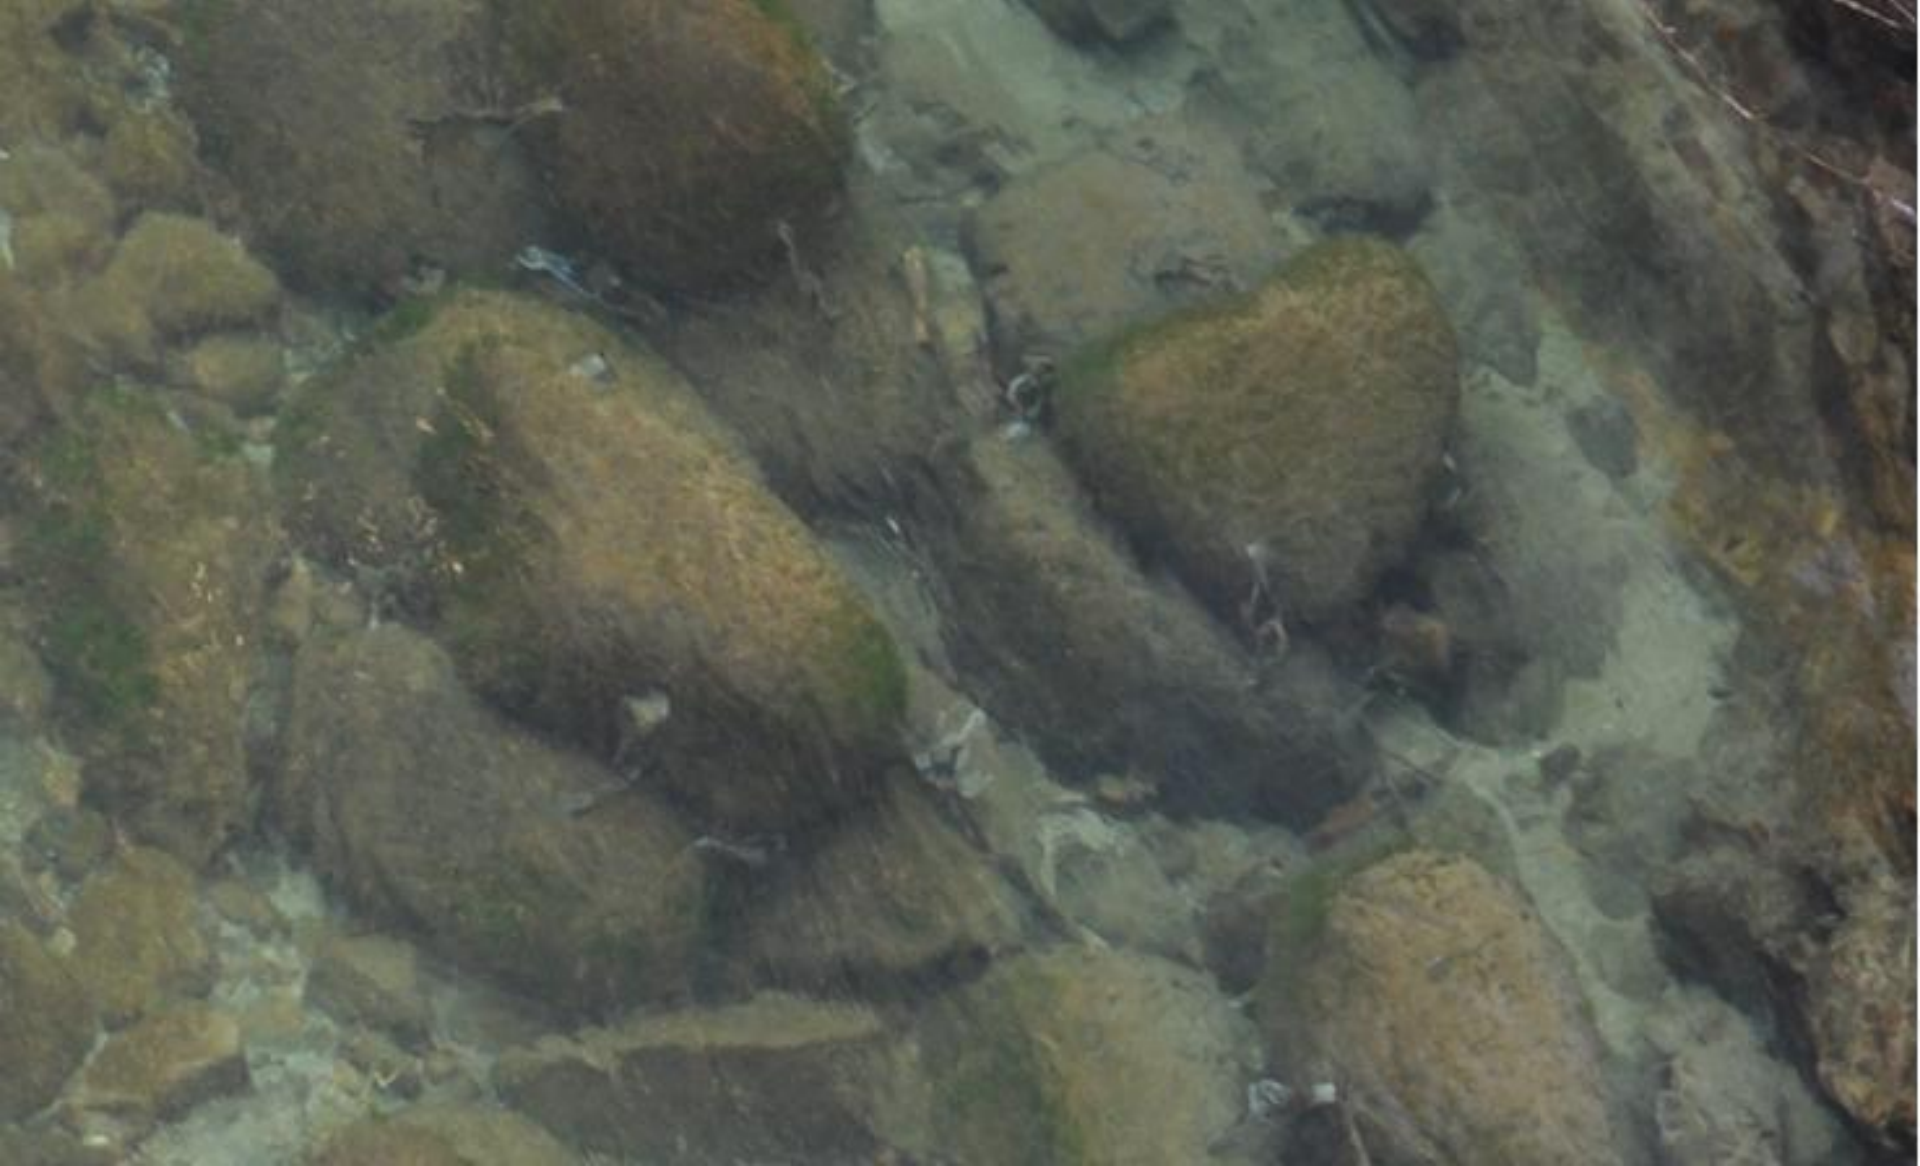
The broken model habitat, rocks with metal parts of binding were scattered on the river floor. The transplantation experiment was not successful.

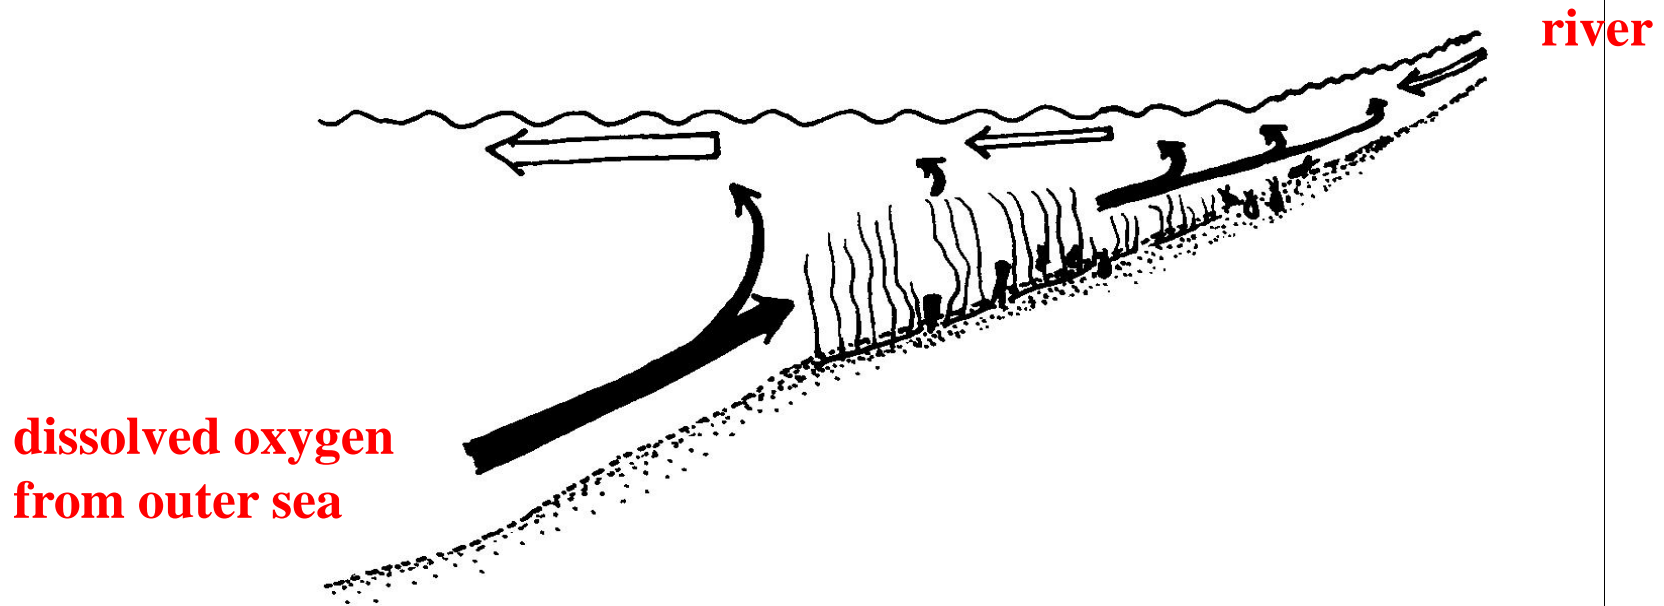
Estuary circulation

River water stimulates the estuary circulation, and transportation of dissolved oxygen and also nutrients from outer sea to the bottom of the bay.

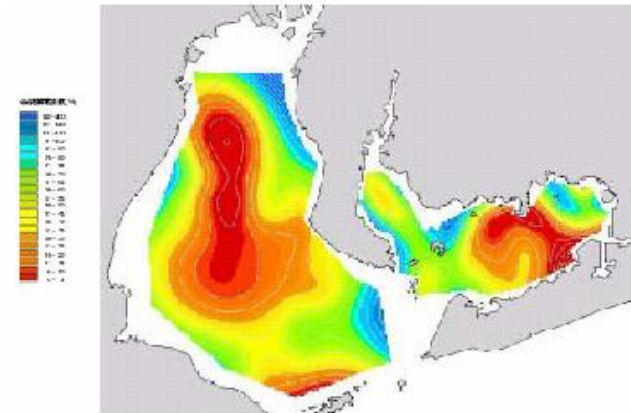
Dissolved oxygen in the bottom region of the bay, 2005,

upper : 14, July

図 伊勢湾 (6月25日、7月6日)・三河湾 (7月14日) 式層の溶存酸素濃度の分布

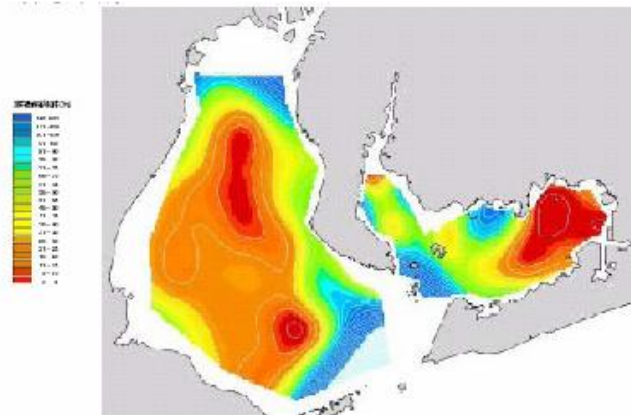
under : 21, July

図 伊勢湾 (7月14、20日)・三河湾 (7月21日) 底層の溶存酸素濃度の分布
